# HISTORIC WESTSIDE DESIGN GUIDELINES

Colorado Springs, Colorado

December, 2009

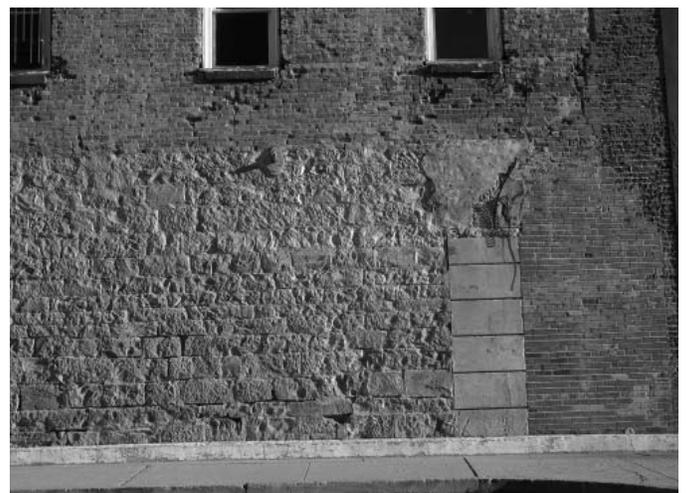
**West wall of 2752 West Colorado showing a remnant of the Heisdick Building original exterior stone wall and a visible remnant of stone pier and partial arch of portico.**

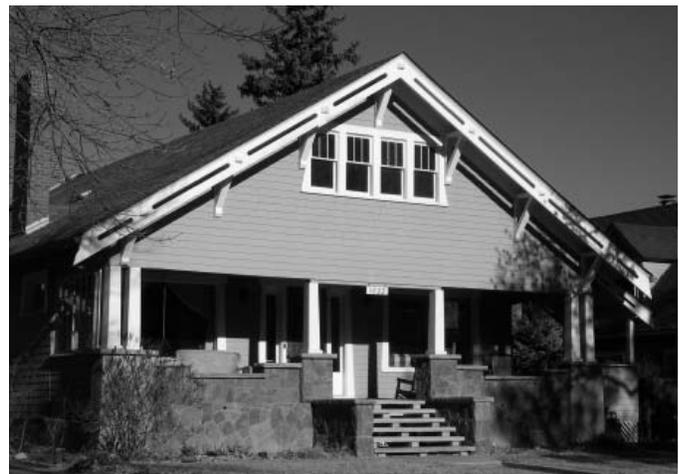
Full gable roof variation with Manitou Greenstone porch half-walls and foundation veneer.

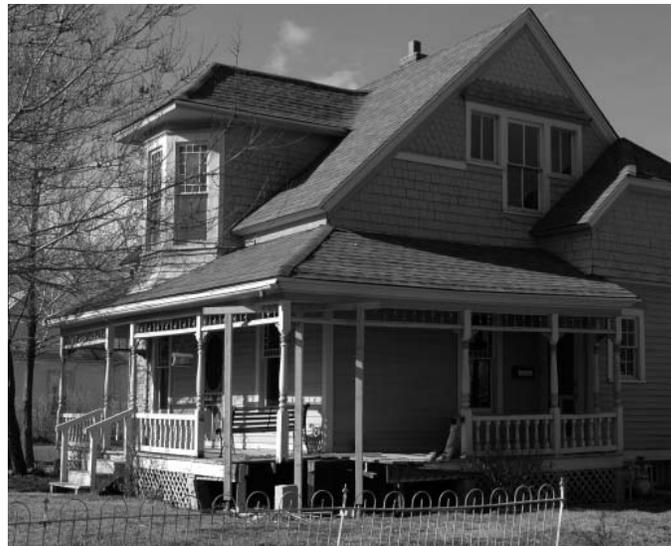
**Before:** Residence undergoing renovations to repair foundation damage and porch deterioration, window replacement, and exterior repairs.

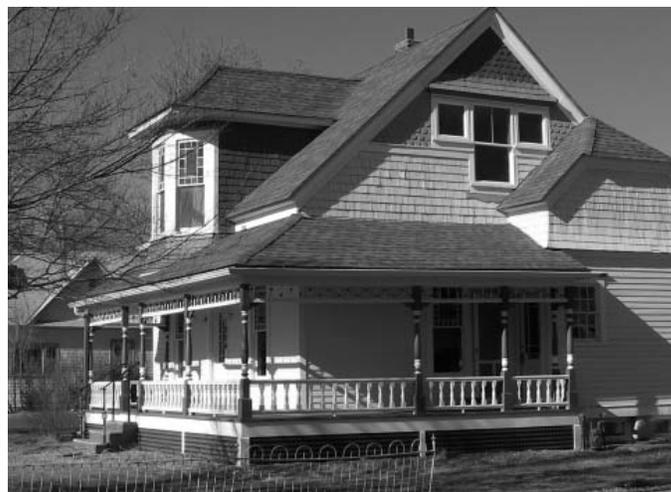
**After:** Completed renovations exhibiting restored porch, new exterior paint, and partial window replacements.

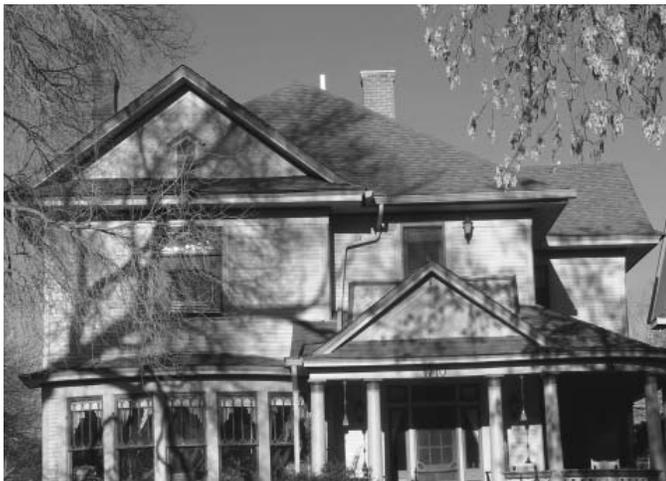
**Edwardian style home with multiple gable elements and a primary hip roof.**

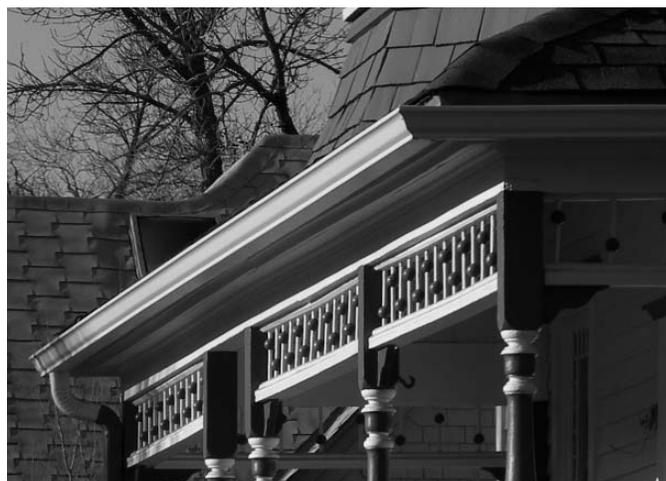
**Example of gutters in good condition and connected to downspout to convey water away from building.**

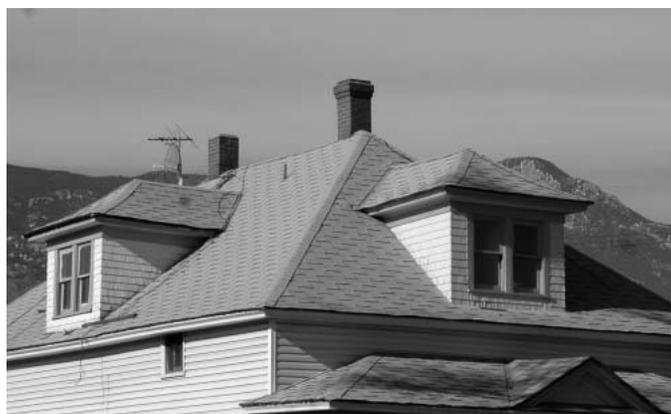
**Classic Cottage with hip roof dormers to match the primary hip roof**

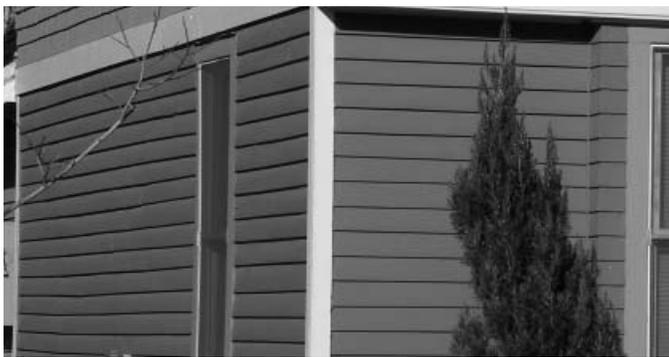
Exterior wall repaired by partial replacement of damaged bevelled cedar siding to match existing siding that has been retained and repaired.

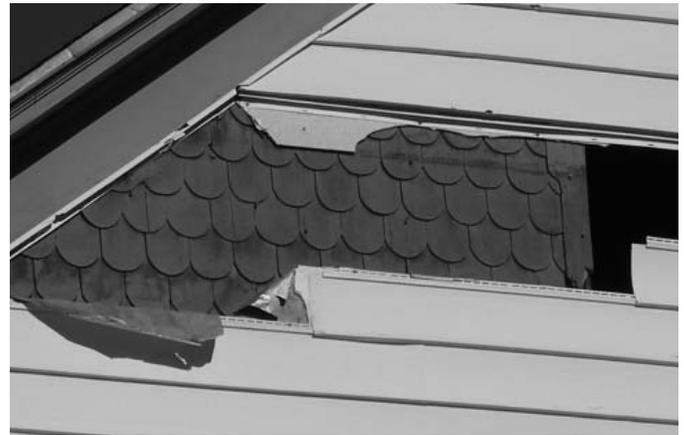
**AVOID** replacement or obscuring of repairable existing siding with new siding whenever possible. When replacing unsalvageable siding, use a similar material and pattern. In this photo, modern vinyl siding was applied over an area of sound historic scalloped wood shingles and an attic window, obscuring the character of the home.

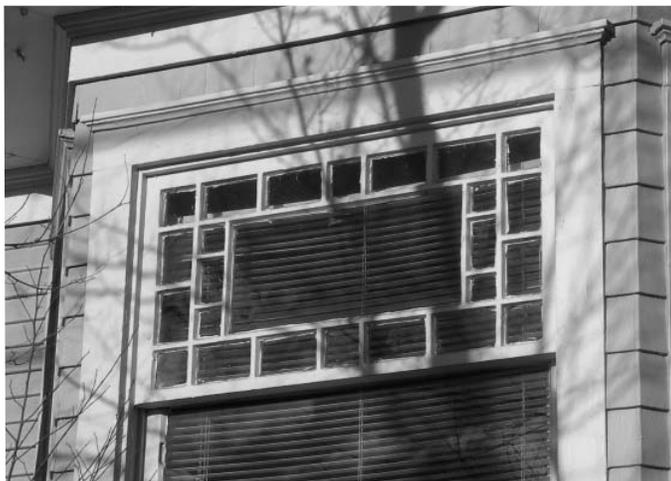
**Ornate preserved wood transom window with multiple small panes divided with wood muntins.**

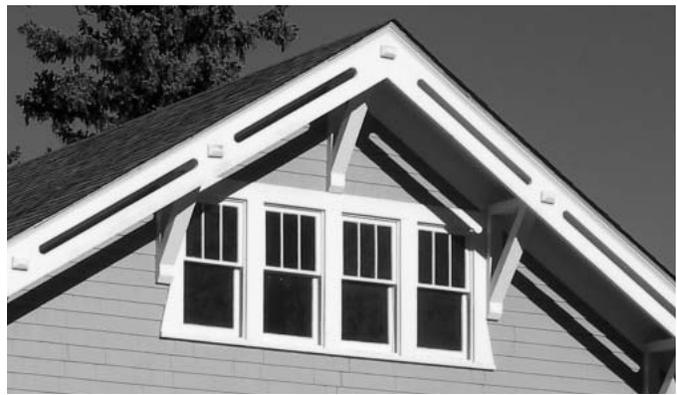
**Grouped bungalow windows with triple pane upper sash.**

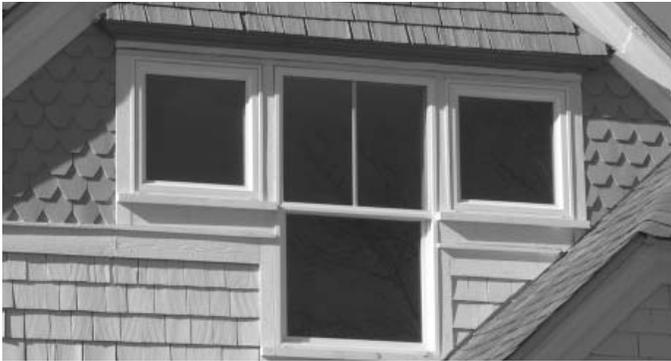
**RECOMMEND** replacement windows match material, size, jamb profile, and appearance of existing.

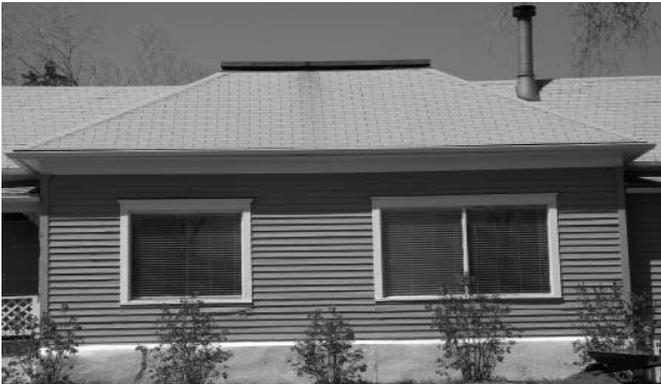
**Replacement windows that do not respect original pattern of tall narrow grouped double sash windows common to the style of house.**

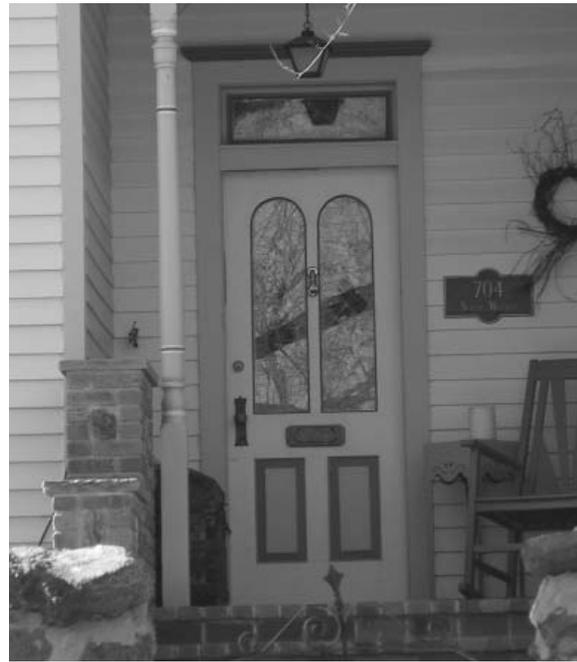
**Preserved historic front door with arched top lites. Window above door is a transom lite.**

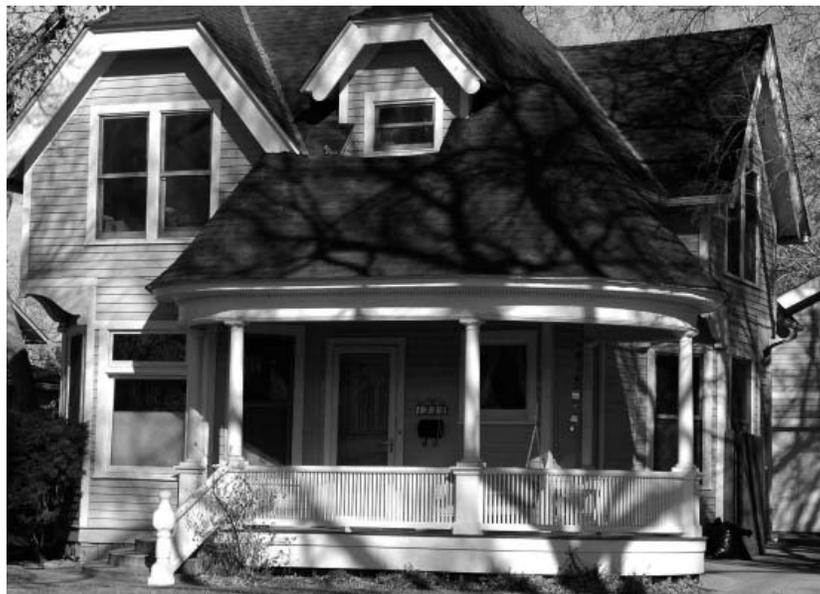
**Example of porch railings reconstructed to historical accuracy by using deteriorated original materials as patterns for accurate replacement elements. The stair newell post is new but is appropriate in style.**

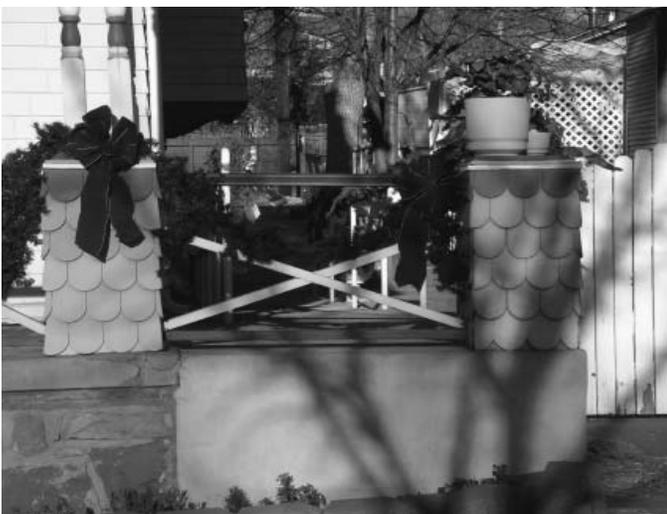
**New handicapped-accessible ramp installed along sideyard and detailed to match porch railings.**

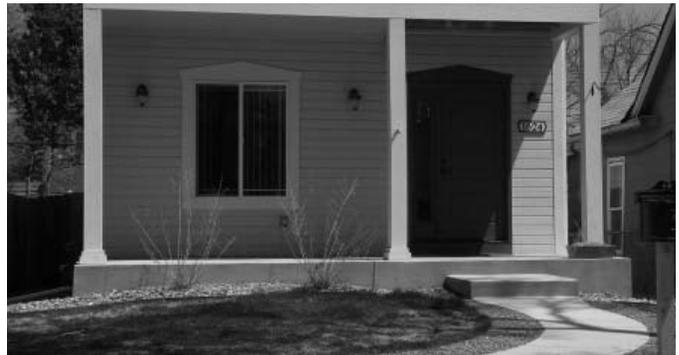
**Example of a building which sits low to the ground and lacks the raised appearance typical of historic residences. Buildings without crawlspaces or basements should have a raised foundation to preserve the typical raised floor relationship above ground.**

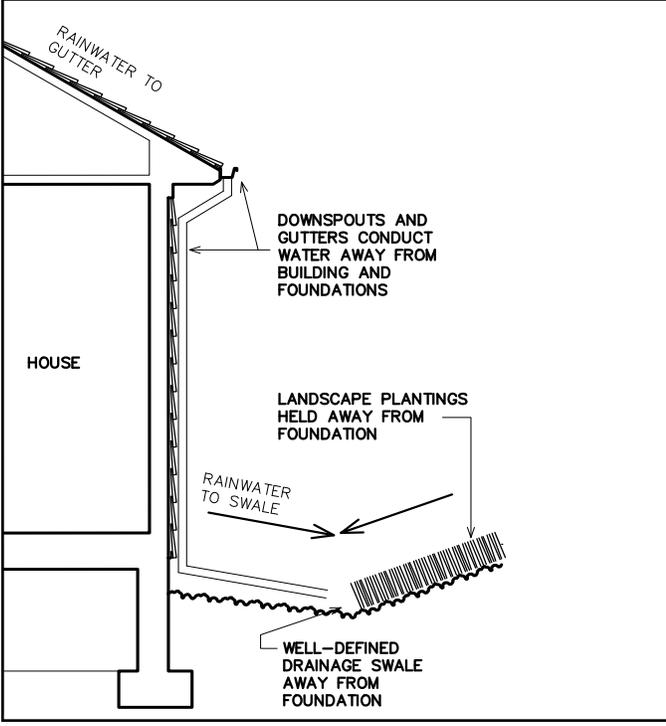
RECOMMEND grading yard soils adjacent to building to conduct roof water away from building for positive drainage.

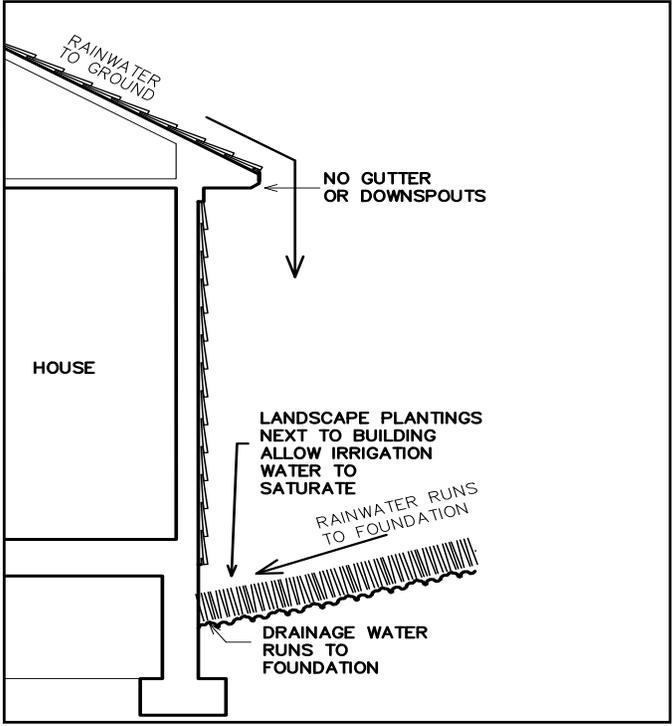
AVOID drainage water and irrigation water collecting adjacent to building.

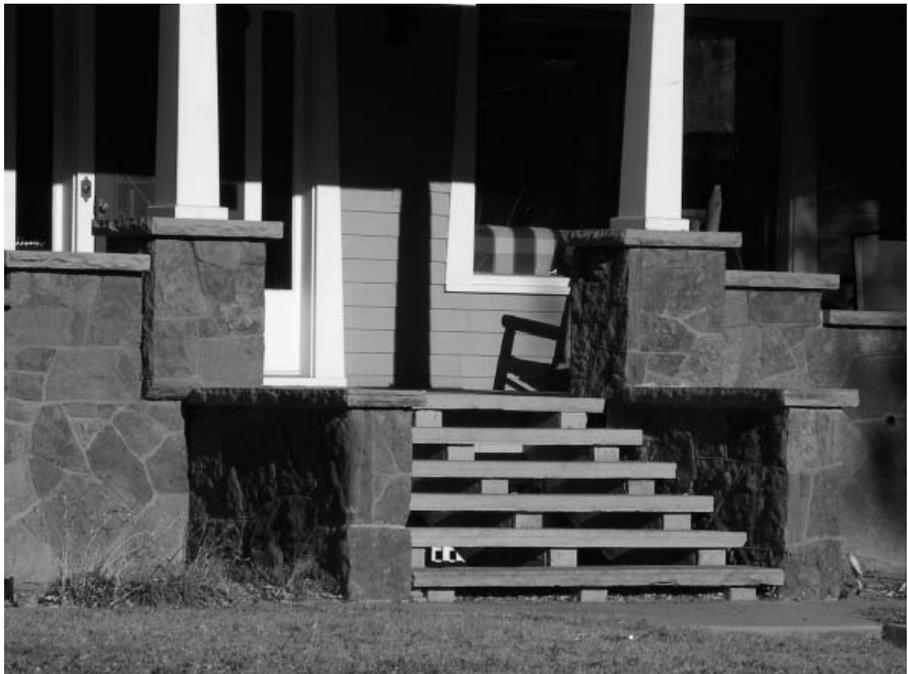
**Manitou greenstone masonry porch wall with slab stone stairway.**

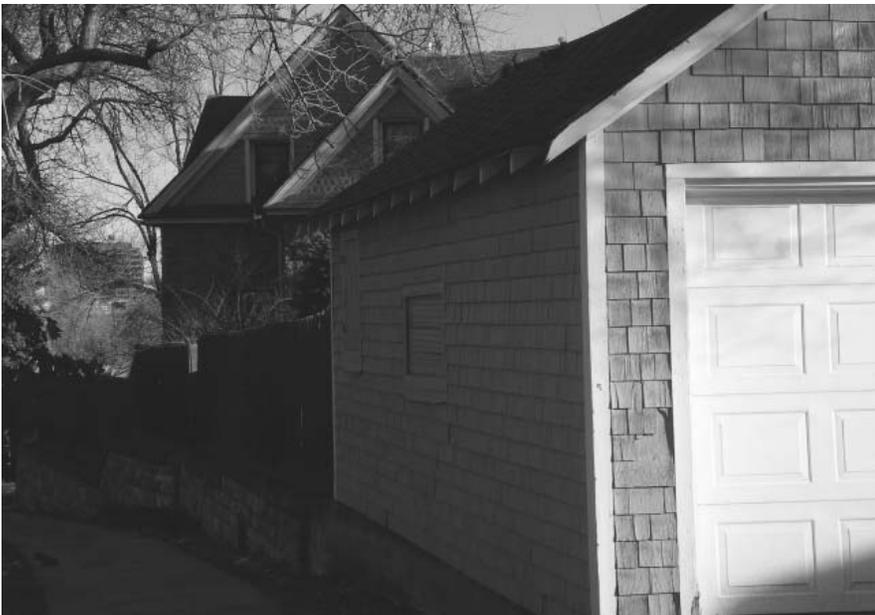
New outbuildings should be subordinate in height, scale, and mass, and located to allow focus on the principal building.

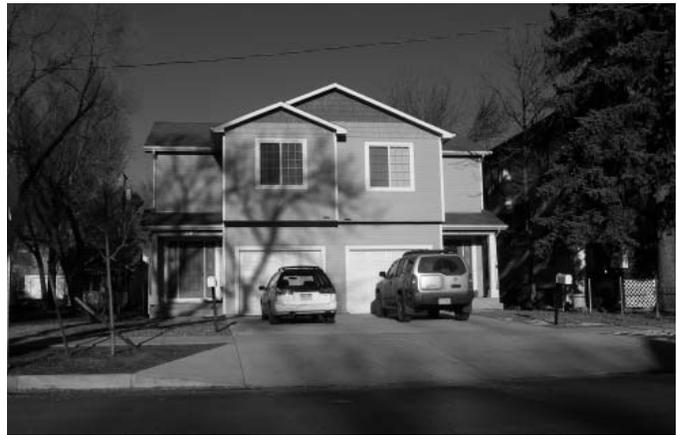
**Recent construction of a large-scale structure that breaks up a wide street face with gables and wall offsets but allows garages to dominate visually. Large driveway results in a deeper front setback and interrupts continuity of front lawn with large paved area.**
